**Flood Control Project Maintenance
Levee Inspections**

Fall 2015 Levee Maintenance Deficiency Summary Report

San Joaquin River Basin

Reclamation District No. 0017 Mossdale

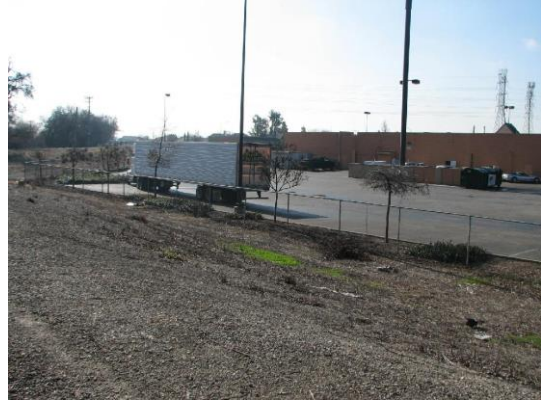
Photo 1 of 3 : UCIP_FA_2015_0698.jpg

View of landward side.

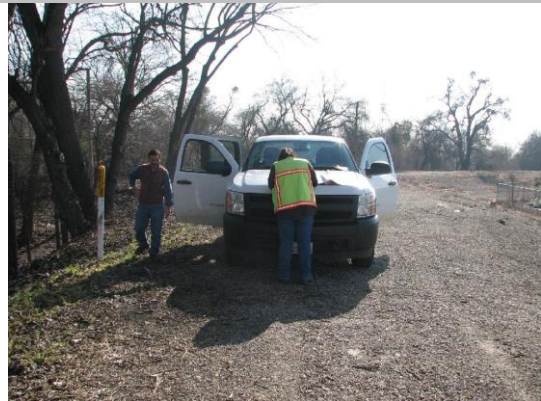
Photo 2 of 3 : UCIP_FA_2015_0699.jpg

View of levee crown at crossing. Marker for line visible on waterward shoulder.

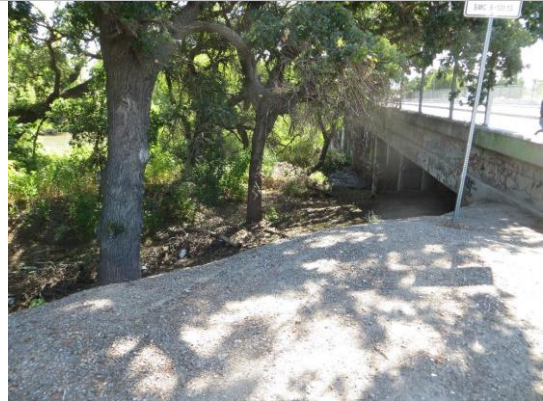
Photo 2 of 3 : UCIP_FA_2015_6722.jpg

Inspector Comments: FS_ID:46010
 DS_ID:72
 EP_NO: 15185
 FS_HLM: 0.15
 Repair Type: Urgent
 Crossing Status: Indicator Found
 UCIP Comments: Need to install gasoline markers.
 FIELD_STRUCT_DESC: 8-inch-diameter soil proofed steel gas main through the left bank levee and under the channel of French Camp Slough. The pipeline has a minimum cover of 5 feet within the overflow areas and under the channel. (Permit No. 15185-1989)
 FS Date: 05/19/2015

WS Slope. No gasoline markers.

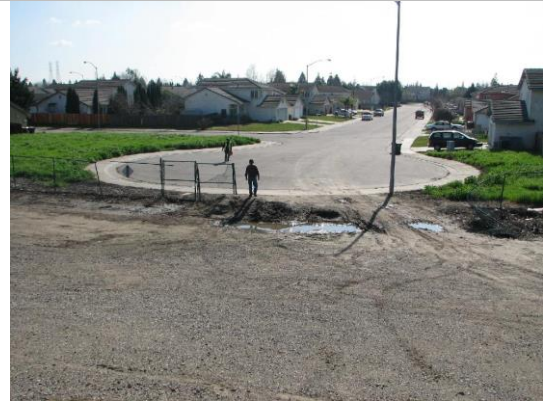
Photo 2 of 3 : UCIP_FA_2015_2336.jpg

View of landward side.

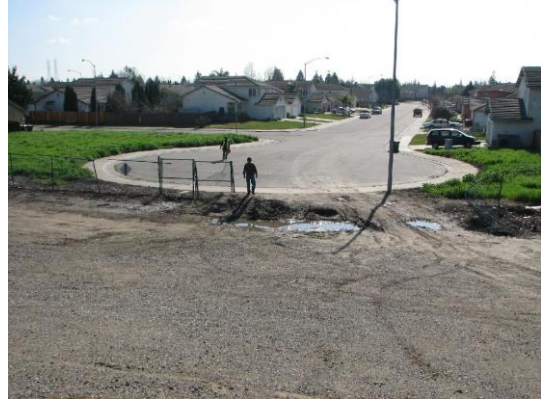
Photo 1 of 3 : UCIP_FA_2015_2335.jpg

View of landward toe--established neighborhood.

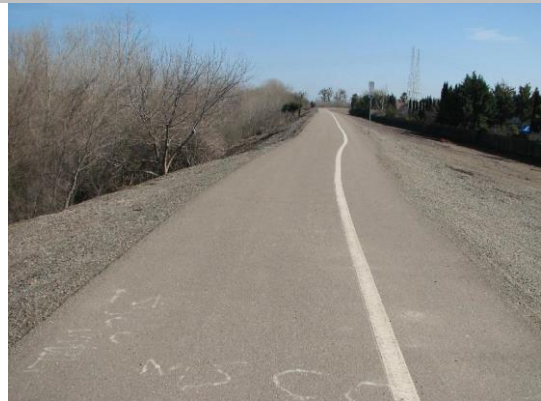
Photo 2 of 3 : UCIP_FA_2015_2337.jpg

Overview of levee at crossing.

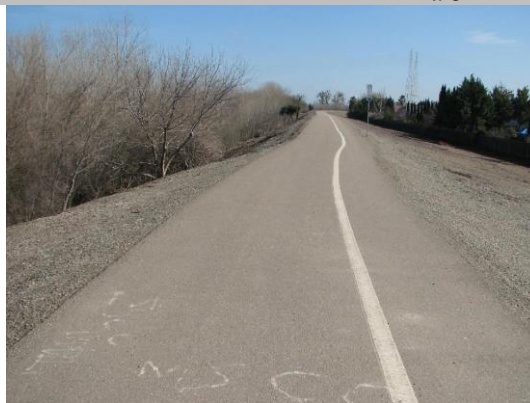
Photo 2 of 3 : UCIP_FA_2015_0702.jpg

Overview of levee crown at crossing.

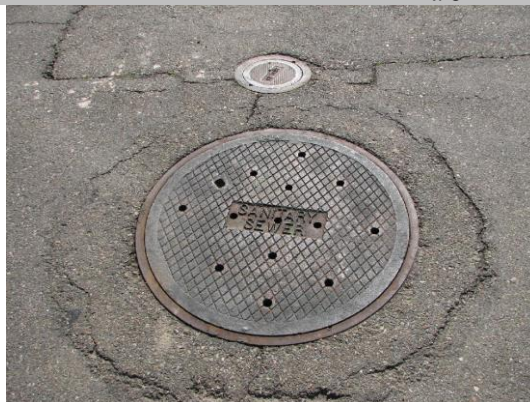
Photo 3 of 3 : UCIP_FA_2015_2334.jpg

Manhole found on landward side.

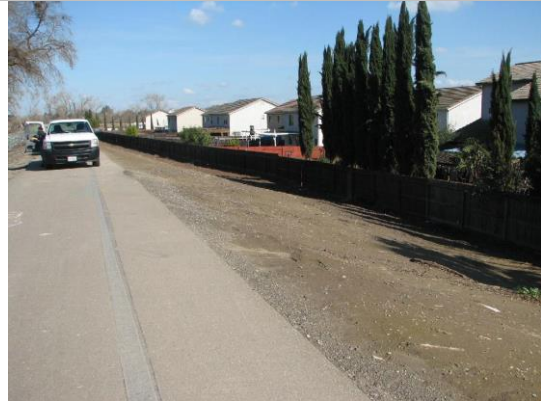
Photo 1 of 3 : UCIP_FA_2015_0557.jpg

View of landward side.

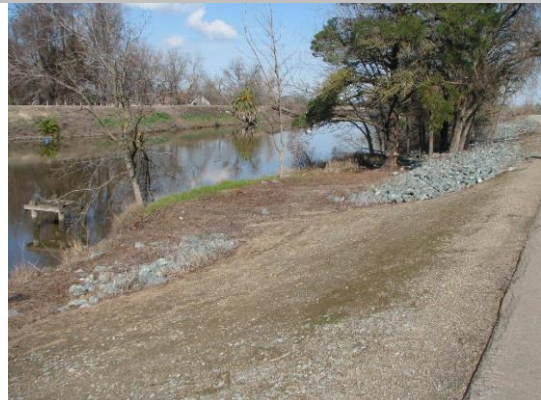
Photo 2 of 3 : UCIP_FA_2015_2340.jpg

View of waterward side.

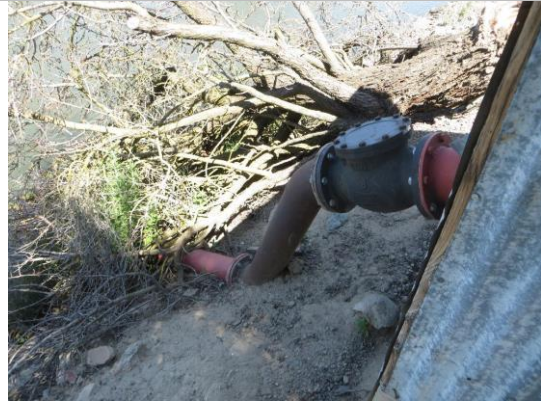
Photo 1 of 3 : UCIP_FA_2015_5971.jpg

(2015) Pipe visible on waterward side.

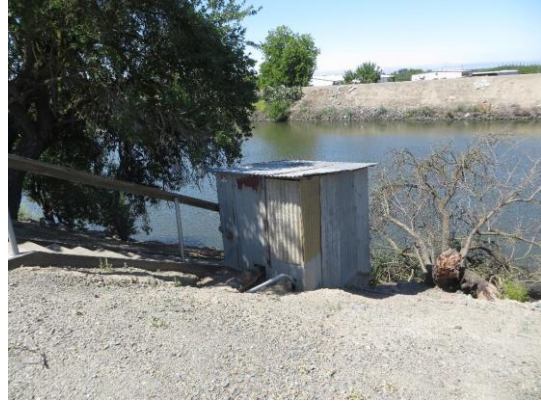
Photo 2 of 3 : UCIP_FA_2015_5972.jpg

(2015) View of waterward side.

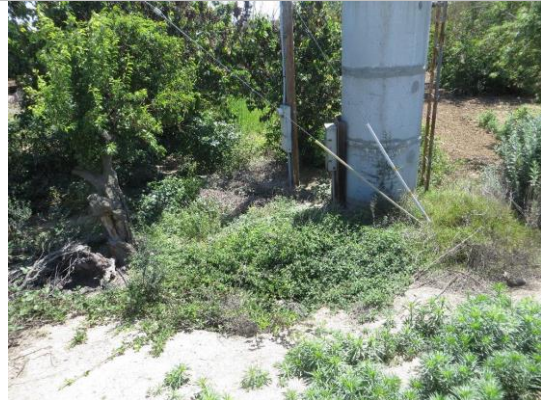
Photo 3 of 3 : UCIP_FA_2015_5973.jpg

(2015) 6 foot hole (covered by dense vegetation) is still present on landward toe.

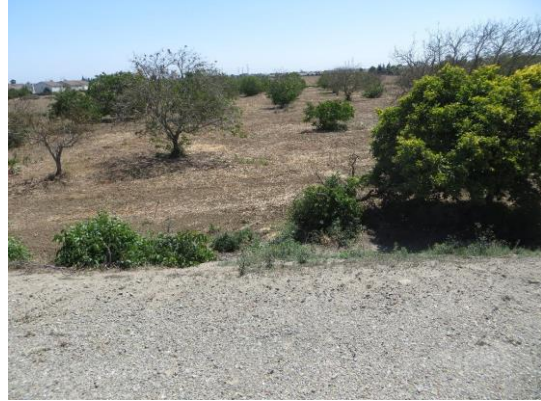
Photo 1 of 2 : UCIP_FA_2015_2567.jpg

No markers on LS.

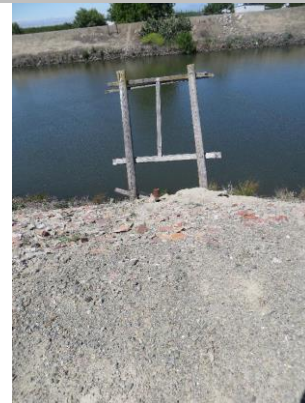
Photo 2 of 2 : UCIP_FA_2015_2568.jpg

Sign post on WS slope.

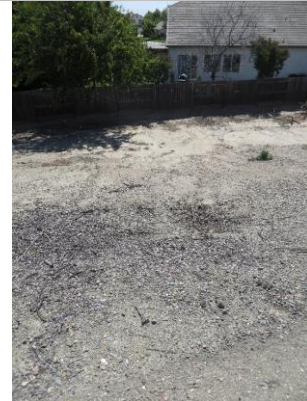
Photo 1 of 2 : UCIP_FA_2015_2569.jpg

View of LS. No appurtenances noted.

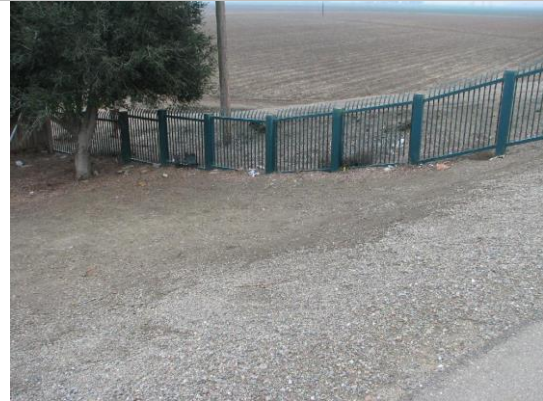
Photo 2 of 3 : UCIP_FA_2015_1866.jpg

View of landward side.

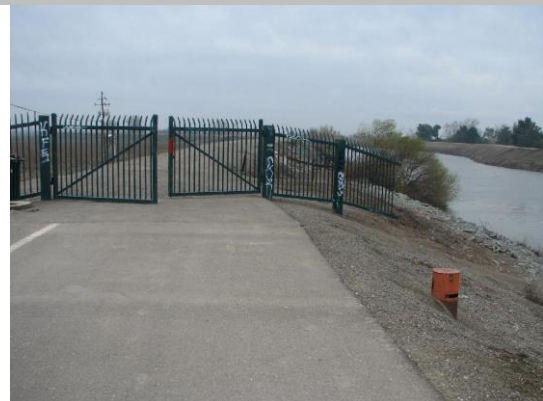
Photo 3 of 3 : UCIP_FA_2015_1867.jpg

View of levee crown at crossing.

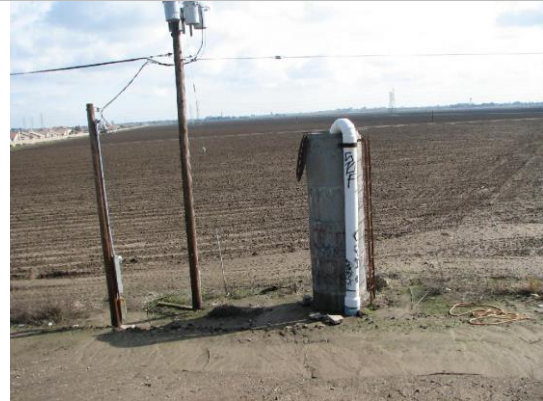
Photo 1 of 3 : UCIP_FA_2015_2432.jpg

Standpipe located on landward side.

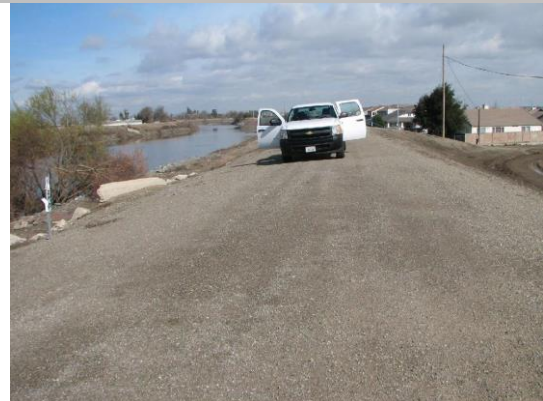
Photo 2 of 3 : UCIP_FA_2015_6508.jpg

View of levee crown at crossing.

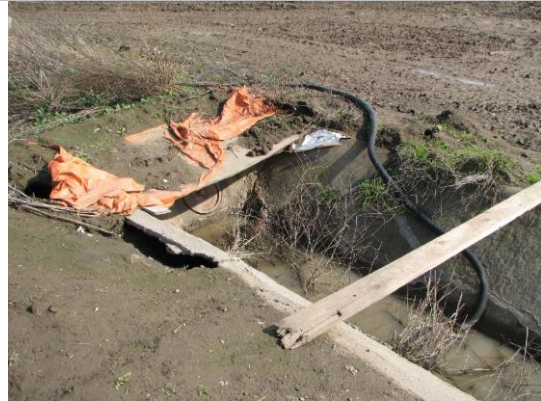
Photo 3 of 3 : UCIP_FA_2015_6509.jpg

Concrete irrigation canal located at landward toe just upstream of crossing.

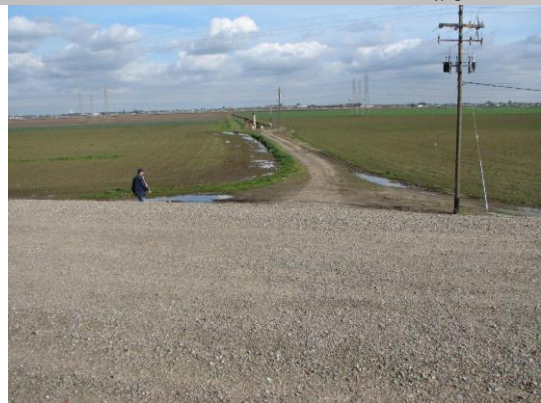
Photo 1 of 2 : UCIP_FA_2015_2529.jpg

View of landward side.

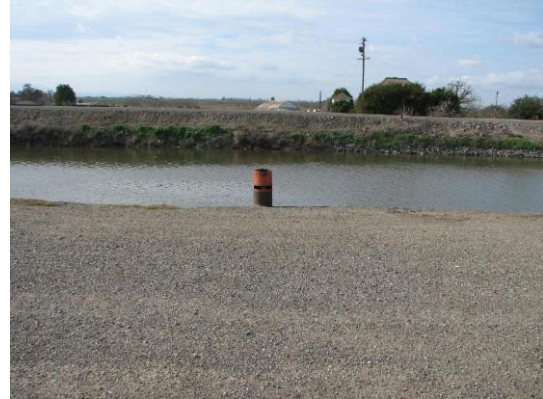
Photo 2 of 2 : UCIP_FA_2015_2530.jpg

View of waterward side--riser located on waterward shoulder.

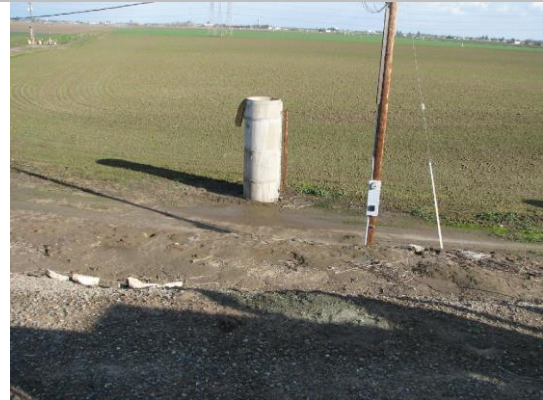
Photo 1 of 3 : UCIP_FA_2015_2561.jpg

View of landward side.

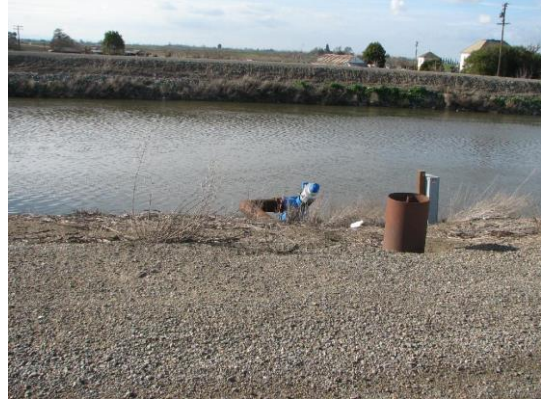
Photo 2 of 3 : UCIP_FA_2015_2562.jpg

View of waterward side.

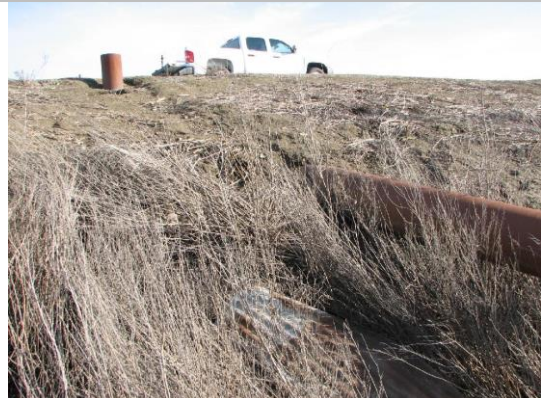
Photo 3 of 3 : UCIP_FA_2015_2563.jpg

View of waterward slope--riser and pipe visible.

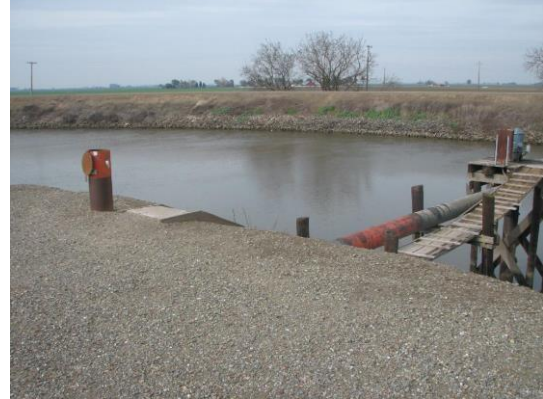
Photo 1 of 3 : UCIP_FA_2015_3775.jpg

Overview of waterward side.

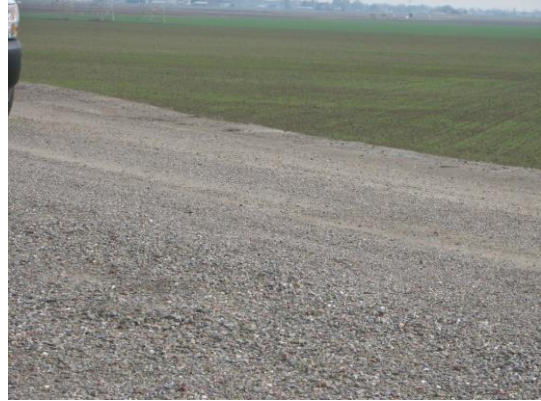
Photo 3 of 3 : UCIP_FA_2015_6512.jpg

View of levee crown at crossing.

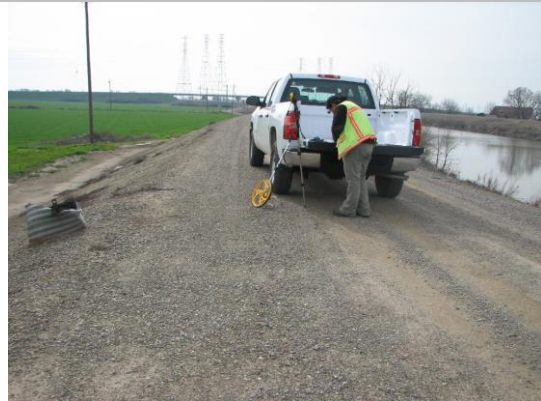
Photo 1 of 3 : UCIP_FA_2015_3773.jpg

View of levee crown at crossing.

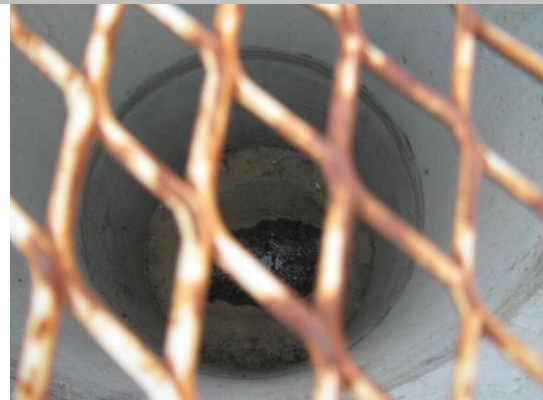
Photo 3 of 3 : UCIP_FA_2015_6510.jpg

Inside view of standpipe located on landward side.

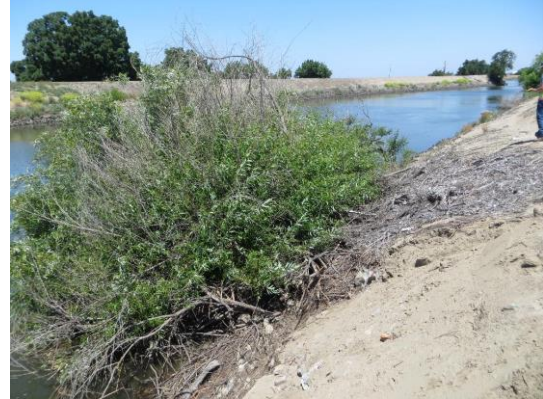
Photo 1 of 3 : UCIP_FA_2015_5974.jpg

(2015) Pipe removed from waterward toe.

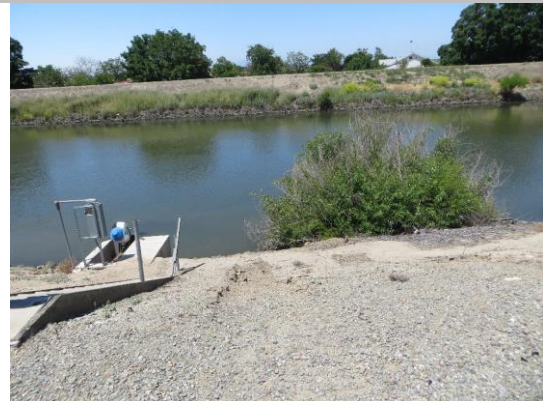
Photo 2 of 3 : UCIP_FA_2015_6001.jpg

(2015) View of waterward slope.

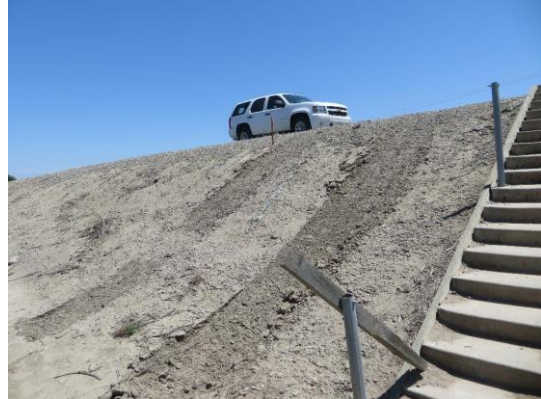
Photo 3 of 3 : UCIP_FA_2015_6002.jpg

LM Start	2.66	Rating **	M	Issue No.	580 (cont)
LM End	2.66	Issue Type +	En	Location *	WS
Category	Supplemental			GPS Latitude/Longitude	
				Start	End
Item	DWR UCIP Field Study			37.881091 °	37.881091 °
				-121.331842 °	-121.331842 °
DWR ID					
Action/Comments					
Inspector Comments: FS_ID:46009					
DS_ID:315					
EP_NO: N/A					
FS_HLM: 2.692					
Repair Type: Non-Urgent					
Crossing Status: Found

(2015) View of waterward slope--pipe removed.

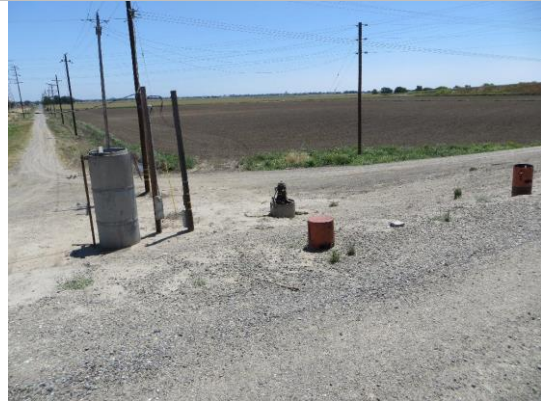
Photo 2 of 3 : UCIP_FA_2015_6004.jpg

LM Start	2.67	Rating **	U	Issue No.	581 (cont)
LM End	2.67	Issue Type +	En	Location *	WS
Category	Supplemental			GPS Latitude/Longitude	
				Start	End
Item	DWR UCIP Field Study			37.880923 °	37.880923 °
				-121.331857 °	-121.331857 °
DWR ID					
Action/Comments					
Inspector Comments: FS_ID:46003 DS_ID:278 EP_NO: 15104 FS_HLM: 2.702 Repair Type: Urgent Crossing Status: Found UCIP Comments: 05/19/15 Holes through pipe visible on waterward toe. Recommend contacting owner to confirm pipe use--good candidate for internal inspection.02/04/10 Need to coordinate with owner to determine status of crossing. If crossing is no longer in use owner will need to contact the CVFPB to comply with Title 23. FIELD_STRUCT_DESC: 3 of 3: 8 inch diameter steel stormdrain pipe through the levee 2.85-feet below levee crown. Pump on Concrete standpipe at LS toe (Permit No. 15104-1989). This pipe was installed during the levee work approved under encroachment number 15014. FS Date: 05/19/2015

(2015) View of landward side.

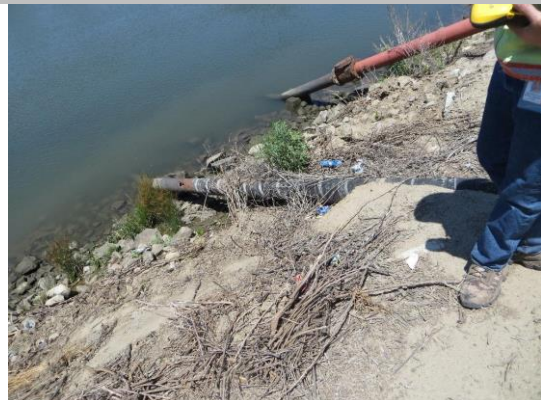
Photo 3 of 3 : UCIP_FA_2015_6005.jpg

(2015) Pipe exposed without coating indicates holes through pipe wall.

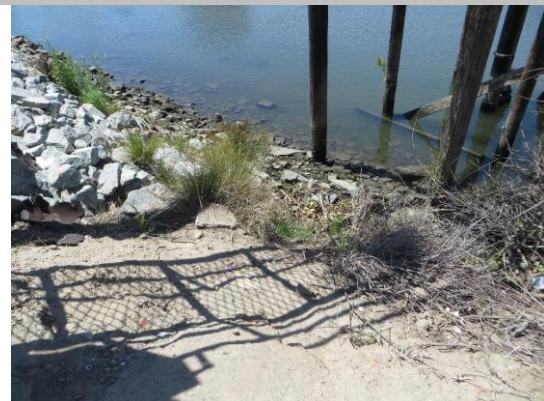
Photo 1 of 3 : UCIP_FA_2015_6006.jpg

LM Start	2.76	Rating **	U	Issue No.	582
LM End	2.76	Issue Type +	En	Location *	WS
Category	Supplemental			GPS Latitude/Longitude	
				Start	End
Item	DWR UCIP Field Study			37.879604 °	37.879604 °
				-121.332109 °	-121.332109 °
DWR ID					
Action/Comments					
Inspector Comments: FS_ID:46004					
DS_ID:19					
EP_NO: 15105					
FS_HLM: 2.796					
Repair Type: Urgent					
Crossing Status: Found

(2015) View of waterward toe along pipe alignment.

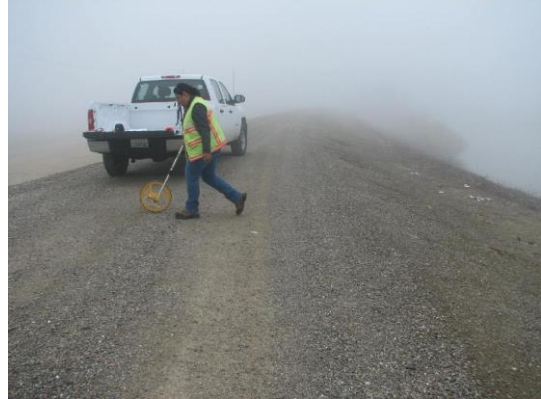
Photo 1 of 3 : UCIP_FA_2015_6630.jpg

LM Start	3.00	Rating **	M	Issue No.	583
LM End	3.00	Issue Type +	En	Location *	WS
Category	Supplemental			GPS Latitude/Longitude	
				Start	End
Item	DWR UCIP Field Study			37.876317 °	37.876317 °
				-121.331447 °	-121.331447 °
DWR ID					
Action/Comments					
Inspector Comments: FS_ID:40655					
DS_ID:20					
EP_NO: 15106					
FS_HLM: 3.035					
Repair Type: Non-Urgent					
Crossing Status: Found

View of levee crown at crossing.

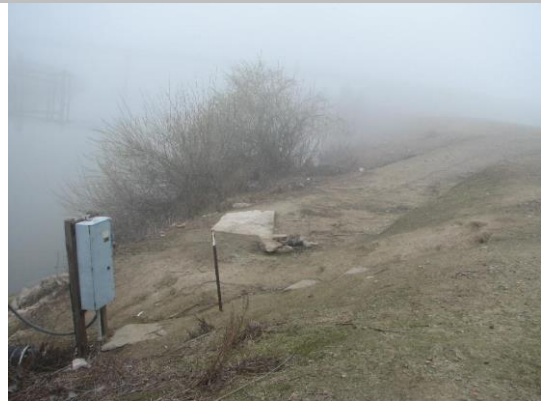
Photo 2 of 3 : UCIP_FA_2015_6631.jpg

View of waterward side.

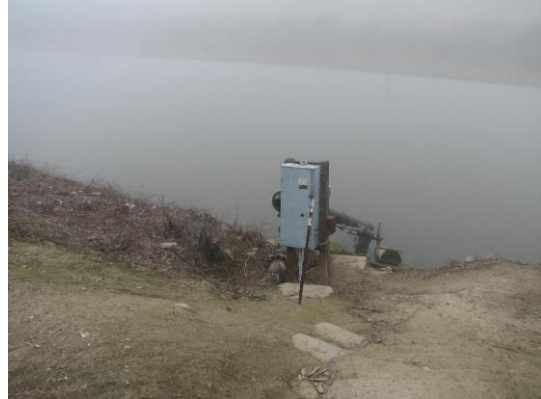
Photo 3 of 3 : UCIP_FA_2015_6632.jpg

LM Start	3.00	Rating **	M	Issue No.	583 (cont)
LM End	3.00	Issue Type +	En	Location *	WS
Category	Supplemental			GPS Latitude/Longitude	
				Start	End
Item	DWR UCIP Field Study			37.876317 °	37.876317 °
				-121.331447 °	-121.331447 °
DWR ID					
Action/Comments					
Inspector Comments: FS_ID:40655					
DS_ID:20					
EP_NO: 15106					
FS_HLM: 3.035					
Repair Type: Non-Urgent					
Crossing Status: Found

Pump station and control panel located on waterward side.

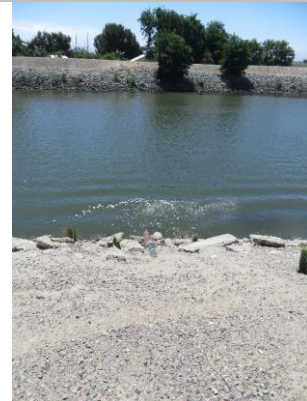
Photo 1 of 3 : UCIP_FA_2015_6009.jpg

LM Start	3.16	Rating **	M	Issue No.	584
LM End	3.16	Issue Type +	En	Location *	WS
Category	Supplemental			GPS Latitude/Longitude	
				Start	End
Item	DWR UCIP Field Study			37.874160 °	37.874160 °
				-121.331761 °	-121.331761 °
DWR ID					
Action/Comments					
Inspector Comments: FS_ID:46005 DS_ID:21 EP_NO: 15310 FS_HLM: 3.202 Repair Type: Non-Urgent Crossing Status: Found UCIP Comments: 05/19/15 Deteriorated section of pipe has been replaced. Need to contact KSN, engineering consulting representing LMA, to determine repair details and to obtain permit authorizing repair.02/04/10 Pipe wall deteriorated. Need to coordinate with owner to determine status of crossing. If crossing is no longer in use owner will need to contact the CVFPB to comply with Title 23. FIELD_STRUCT_DESC: 10 inch discharge pipeline through levee. The invert of the pipe is 3.78 feet below crown. Siphon breaker on landward shoulder. Pump located on the landward side approximately 45 feet from the levee toe. (Permit No. 15310-1989) This pipe was installed during the levee work approved under encroachment number 15014. FS Date: 05/19/2015

(2015) View of waterward side.

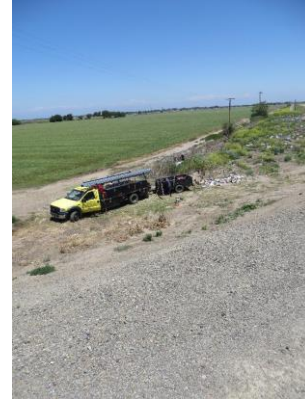
Photo 2 of 3 : UCIP_FA_2015_6010.jpg

Inspector Comments: FS_ID:46005
 DS_ID:21
 EP_NO: 15310
 FS_HLM: 3.202
 Repair Type: Non-Urgent
 Crossing Status: Found
 UCIP Comments: 05/19/15 Deteriorated section of pipe has been replaced. Need to contact KSN, engineering consulting representing LMA, to determine repair details and to obtain permit authorizing repair. 02/04/10 Pipe wall deteriorated. Need to coordinate with owner to determine status of crossing. If crossing is no longer in use owner will need to contact the CVFPB to comply with Title 23.
 FIELD_STRUCT_DESC: 10 inch discharge pipeline through levee. The invert of the pipe is 3.78 feet below crown. Siphon breaker on landward shoulder. Pump located on the landward side approximately 45 feet from the levee toe. (Permit No. 15310-1989) This pipe was installed during the levee work approved under encroachment number 15014.
 FS Date: 05/19/2015

(2015) View of landward side.

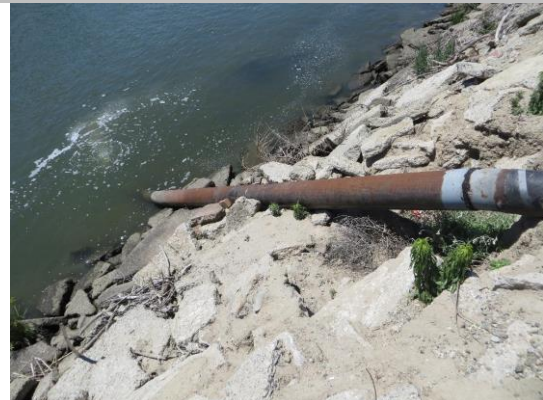
Photo 3 of 3 : UCIP_FA_2015_6011.jpg

(2015) Pipe section replaced.

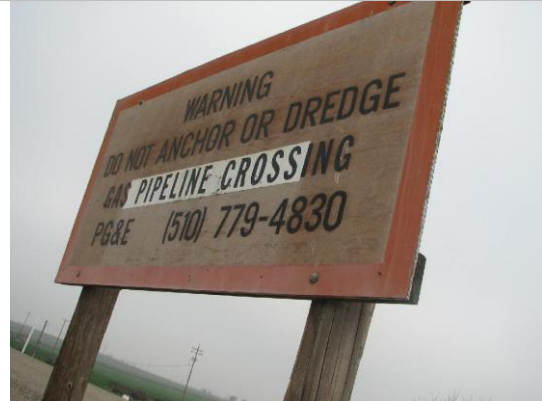
Photo 1 of 3 : UCIP_FA_2015_6806.jpg

LM Start	3.47	Rating **	M	Issue No.	585
LM End	3.47	Issue Type +	En	Location *	WS
Category	Supplemental			GPS Latitude/Longitude	
				Start	End
Item	DWR UCIP Field Study			37.870623 °	37.870623 °
				-121.328775 °	-121.328775 °
DWR ID					
Action/Comments					
Inspector Comments: FS_ID:40658					
DS_ID:23					
EP_NO: 4116					
FS_HLM: 3.5145					
Repair Type: Non-Urgent					
Crossing Status: Found

Marker visible on waterward side.

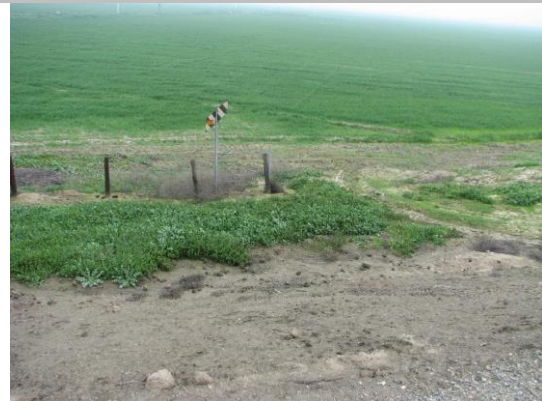
Photo 2 of 3 : UCIP_FA_2015_6807.jpg

View of landward side.

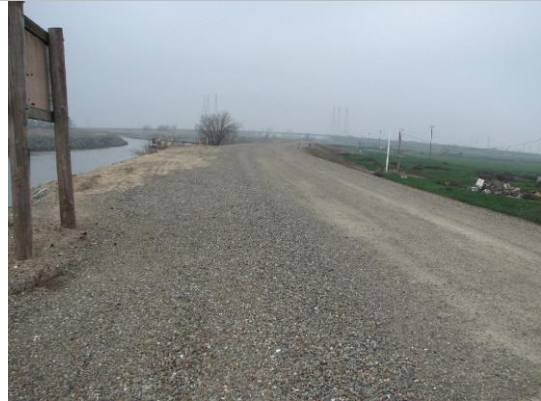
Photo 3 of 3 : UCIP_FA_2015_6808.jpg

LM Start	3.47	Rating **	M	Issue No.	585 (cont)
LM End	3.47	Issue Type +	En	Location *	WS
Category	Supplemental			GPS Latitude/Longitude	
				Start	End
Item	DWR UCIP Field Study			37.870623 °	37.870623 °
				-121.328775 °	-121.328775 °
DWR ID					
Action/Comments					
Inspector Comments: FS_ID:40658					
DS_ID:23					
EP_NO: 4116					
FS_HLM: 3.5145					
Repair Type: Non-Urgent					
Crossing Status: Found

View of levee crown at crossing.

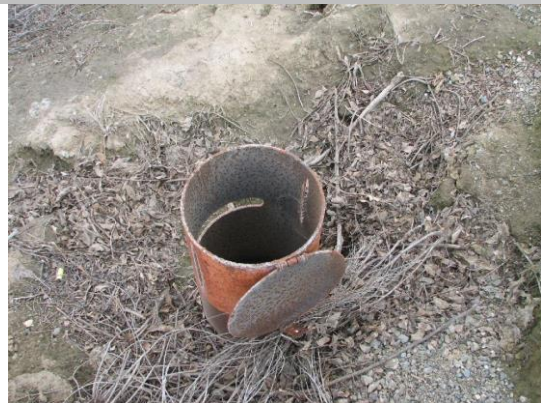
Photo 1 of 3 : UCIP_FA_2015_6809.jpg

Siphon breaker located on landward slope.

Action/Comments					
Inspector Comments: FS_ID:40659 DS_ID:26 EP_NO: 15109 FS_HLM: 3.6721 Repair Type: Non-Urgent Crossing Status: Found UCIP Comments: Erosion around siphon breaker on landward side recommend investigating potential leak. FIELD_STRUCT_DESC: 12 inch pipeline through levee. Invert of pipe is 4.0 feet below levee crown. Siphon breaker on landward shoulder. Pump in irrigation ditch 45 feet from landward toe. (Permit No. 15109-1990) FS Date: 02/04/2010

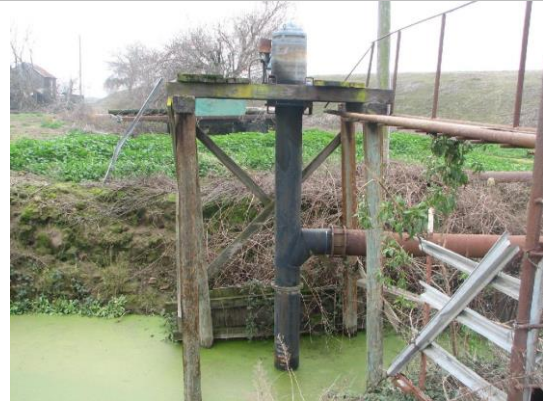
Photo 2 of 3 : UCIP_FA_2015_6810.jpg

Pump station locate on landward side.

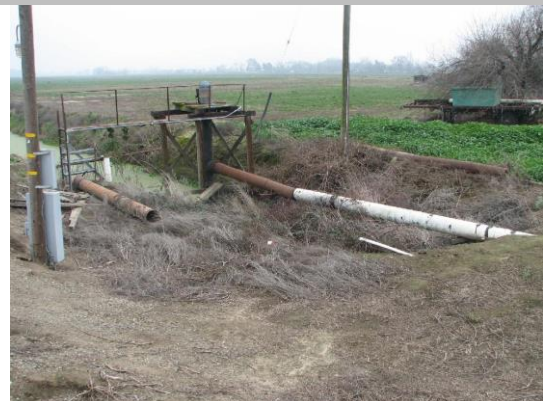
Photo 3 of 3 : UCIP_FA_2015_6811.jpg

View of pipe section and pump station located on landward side.

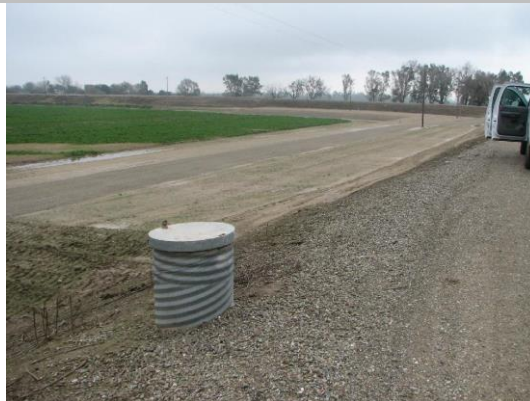
Photo 2 of 3 : UCIP_FA_2015_6846.jpg

Inspector Comments: FS_ID:40660
 DS_ID:27
 EP_NO: 15110
 FS_HLM: 3.7789
 Repair Type: Non-Urgent
 Crossing Status: Found
 UCIP Comments: Need to coordinate with owner to determine status of crossing. If crossing is no longer in use owner will need to contact the CVFPB to comply with Title 23.
 FIELD_STRUCT_DESC: 12 inch diameter irrigation pipeline through levee. Invert of pipe is 3.88 below levee crown. Siphon breaker on landward shoulder. Pump on landward slope, standpipe located 10 feet from the landward toe stairway. (Permit No. 15110-1989)
 FS Date: 02/04/2010

Seepage berm located on landward side.

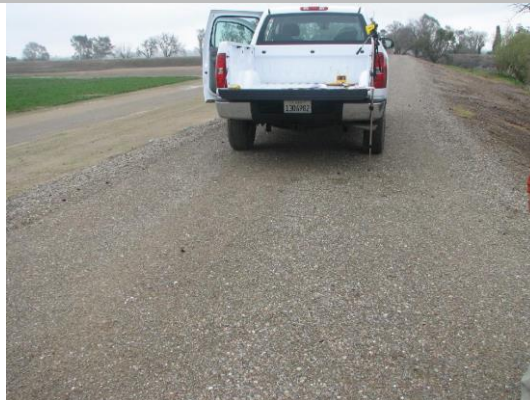
Photo 3 of 3 : UCIP_FA_2015_6847.jpg

View of levee crown at crossing.

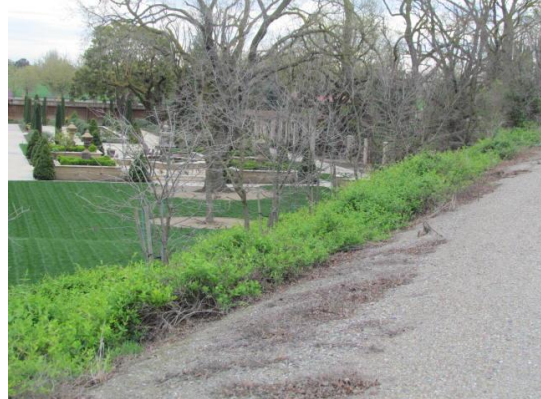
Photo 1 of 3 : FA_2015_RD0017_304_48_20150914_00008.jpg

LM Start	4.19	Rating **	A/W	Issue No.	48
LM End	4.22	Issue Type +	En	Location *	LS
Category	Earthen Levee			GPS Latitude/Longitude	
				Start	End
Item	Vegetation			37.863819 °	37.863601 °
				-121.320784 °	-121.320299 °
DWR ID	DWR_RD0017_02_s _ 2012_48				
Action/Comments					
Landscaping

Looking southeast at dense ground cover on landside slope. (Spring 2013)

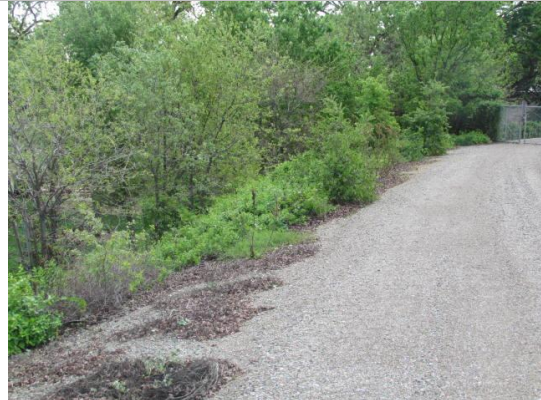
Photo 2 of 3 : FA_2015_RD0017_304_48_20150914_00009.jpg

Looking southeast at overgrown landscaping on landside slope. (Spring 2014)

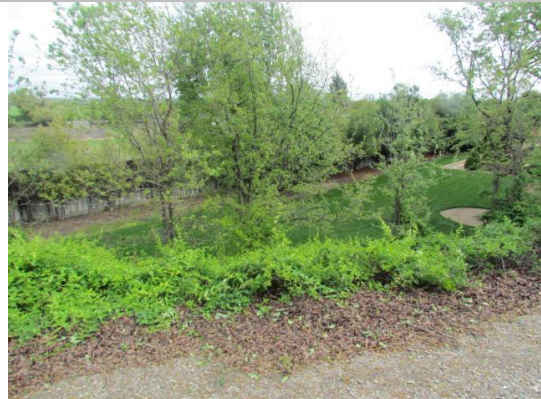
Photo 3 of 3 : FA_2015_RD0017_304_48_20150914_00010.jpg

Looking east at overgrown landscaping on landside slope. (Spring 2014)

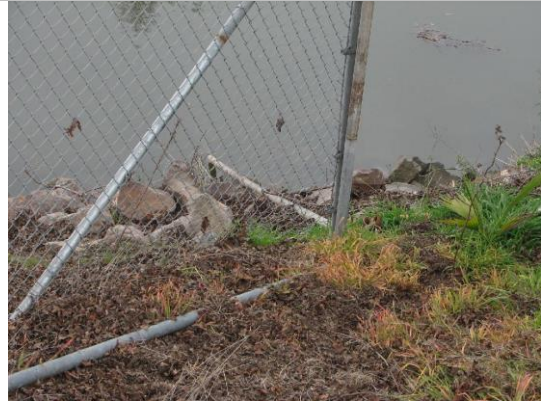
Photo 1 of 3 : UCIP_FA_2015_6848.jpg

LM Start	4.21	Rating **	M	Issue No.	588
LM End	4.21	Issue Type +	En	Location *	LS
Category	Supplemental			GPS Latitude/Longitude	
				Start	End
Item	DWR UCIP Field Study			37.863644 °	37.863644
				-121.320435 °	-121.320435
DWR ID					
Action/Comments					
Inspector Comments: FS_ID:43264					
DS_ID:28					
EP_NO: 15111					
FS_HLM: 4.268					
Repair Type: Non-Urgent					
Crossing Status: Found

View of crossing on waterward side.

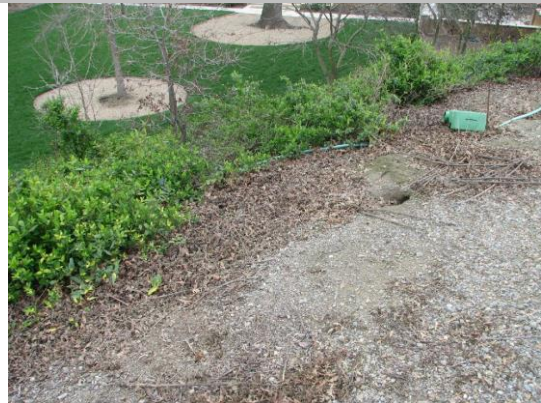
Photo 2 of 3 : UCIP_FA_2015_6849.jpg

View of landward side.

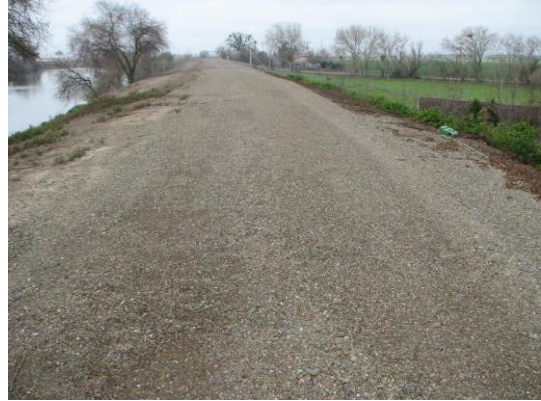
Photo 3 of 3 : UCIP_FA_2015_6850.jpg

LM Start	4.21	Rating **	M	Issue No.	588 (cont)
LM End	4.21	Issue Type +	En	Location *	LS
Category	Supplemental			GPS Latitude/Longitude	
				Start	End
Item	DWR UCIP Field Study			37.863644 °	37.863644
				-121.320435 °	-121.320435
DWR ID					
Action/Comments					
Inspector Comments: FS_ID:43264					
DS_ID:28					
EP_NO: 15111					
FS_HLM: 4.268					
Repair Type: Non-Urgent					
Crossing Status: Found

View of levee crown at crossing.

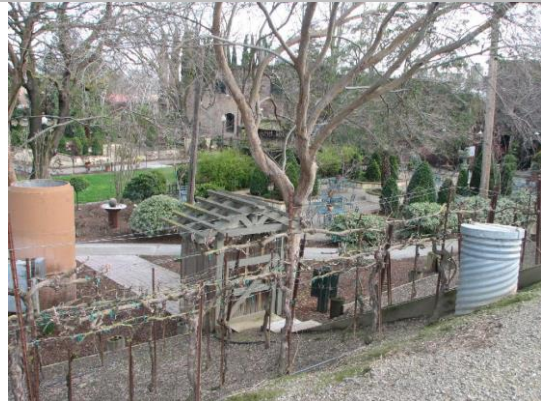
Photo 1 of 3 : UCIP_FA_2015_6184.jpg

LM Start	4.26	Rating **	M	Issue No.	589
LM End	4.26	Issue Type +	En	Location *	LS
Category	Supplemental			GPS Latitude/Longitude	
				Start	End
Item	DWR UCIP Field Study			37.863195 °	37.863195 °
				-121.319920 °	-121.319920 °
DWR ID					
Action/Comments					
Inspector Comments: FS_ID:40662 DS_ID:29 EP_NO: 15112 FS_HLM: 4.3115 Repair Type: Non-Urgent Crossing Status: Found UCIP Comments: Need to coordinate with owner to determine status of crossing. If crossing is no longer in use owner will need to contact the CVFPB to comply with Title 23. Debris (pipe section) scattered on waterward side. FIELD_STRUCT_DESC: 10 inch diameter irrigation pipeline through levee. Invert of pipe is 4.12 feet below crown. Siphon breaker on landward shoulder. Pump on waterward berm, standpipe located 28 feet from the landward toe. (Permit No. 15112-1990). Stairway located on both waterward and landward slopes. This pipe was installed during the levee work approved under encroachment number 15014. FS Date: 02/04/2010

View of landward side.

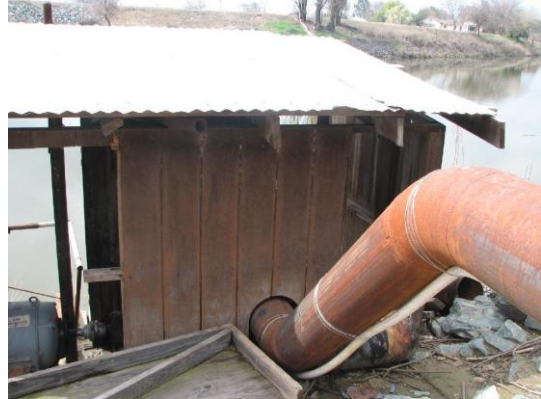
Photo 2 of 3 : UCIP_FA_2015_6185.jpg

Inspector Comments: FS_ID:40662
 DS_ID:29
 EP_NO: 15112
 FS_HLM: 4.3115
 Repair Type: Non-Urgent
 Crossing Status: Found
 UCIP Comments: Need to coordinate with owner to determine status of crossing. If crossing is no longer in use owner will need to contact the CVFPB to comply with Title 23. Debris (pipe section) scattered on waterward side.
 FIELD_STRUCT_DESC: 10 inch diameter irrigation pipeline through levee. Invert of pipe is 4.12 feet below crown. Siphon breaker on landward shoulder. Pump on waterward berm, standpipe located 28 feet from the landward toe. (Permit No. 15112-1990). Stairway located on both waterward and landward slopes. This pipe was installed during the levee work approved under encroachment number 15014.
 FS Date: 02/04/2010

Pipe through pump house located on waterward side.

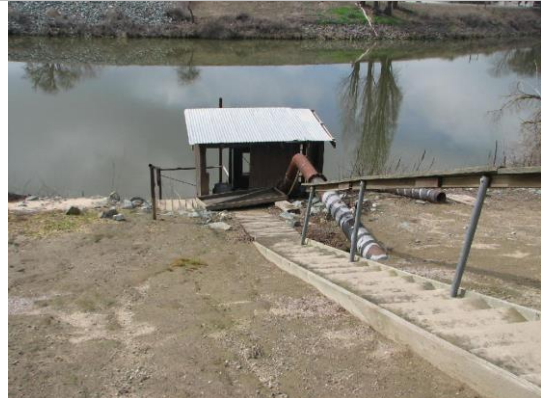
Photo 3 of 3 : UCIP_FA_2015_6851.jpg

View of waterward side--pump house, walkway, pipe, and abandoned pipe section.

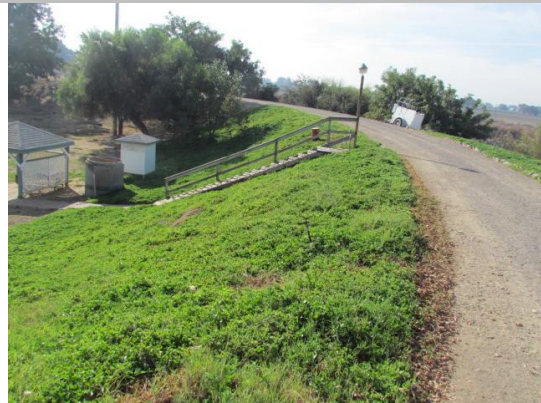
Photo 1 of 3 : FA_2015_RD0017_304_1_20150914_00001.jpg

Looking southeast at ground cover on landside slope.

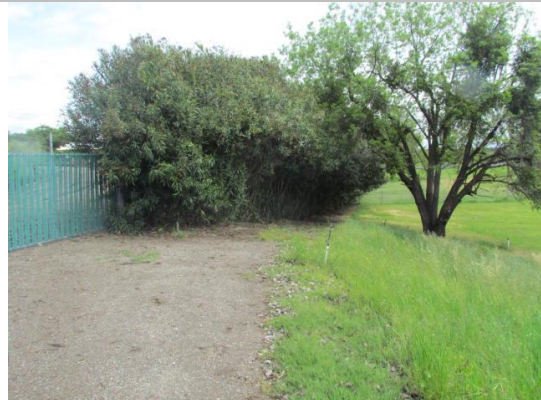
Photo 2 of 3 : FA_2015_RD0017_304_1_20150914_00002.jpg

Looking south at overgrown oleanders on landside shoulder. (Spring 2014)

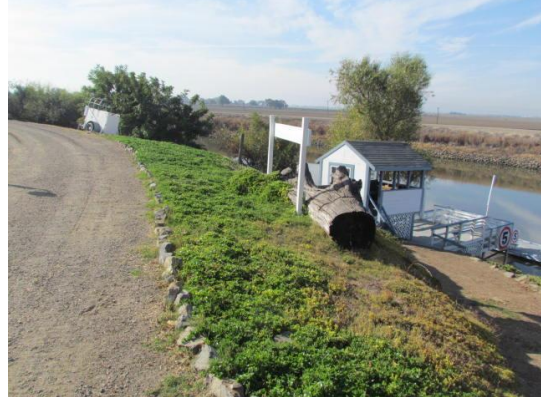
Photo 3 of 3 : FA_2015_RD0017_304_1_20150914_00003.jpg

LM Start	4.37	Rating **	M	Issue No.	1 (cont)
LM End	4.39	Issue Type +	En	Location *	LS
Category	Earthen Levee			GPS Latitude/Longitude	
				Start	End
Item	Vegetation			37.861673 °	37.861370 °
				-121.320115 °	-121.320102 °
DWR ID	DWR_RD0017_02_s_2012_1				
Action/Comments					
Landscaping					
Inspector Comments: Oleander along fence line.

Looking southwest at landscaping and boat dock on waterside slope and channel.

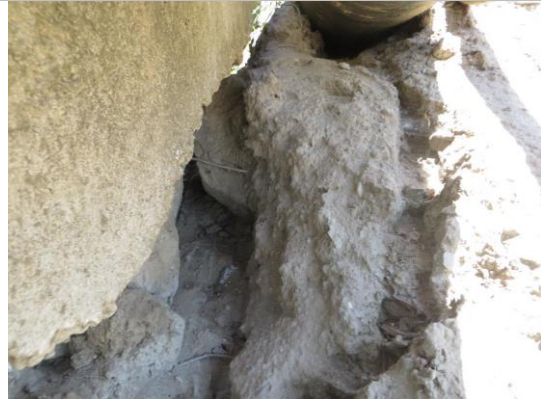
Photo 1 of 3 : UCIP_FA_2015_6012.jpg

LM Start	4.80	Rating **	U	Issue No.	591
LM End	4.80	Issue Type +	En	Location *	LS
Category	Supplemental			GPS Latitude/Longitude	
				Start	End
Item	DWR UCIP Field Study			37.856998 °	37.856998 °
				-121.318796 °	-121.318796 °
DWR ID					
Action/Comments					
Inspector Comments: FS_ID:46007 DS_ID:33 EP_NO: 15116 FS_HLM: 4.861 Repair Type: Urgent Crossing Status: Found UCIP Comments: 05/19/2015 Signs of internal erosion visible on waterward side where pipe daylights. Slope slumping visible on landward side where previous levee damage was present. Need to contact owner and KSN, LMA engineering firm, to coordinate potential issues with pipe.02/04/2010 Pipe failure--internal erosion visible on waterward and landward side. Recommend LMA superintendent notify owner to stop using crossing to avoid further damage to levee slope. Owner will need to coordinate with DWR Inspector and CVFPB to address pipe failure per Title 23 requirements. FIELD_STRUCT_DESC: 14 inch diameter pipe through levee. Invert pipe is 4.83 feet below levee crown. Siphon breaker on waterward shoulder. Pump on platform in channel, wooden walkway extends from pump platform to waterward slope, concrete stairway extends from walkway to waterward shoulder. A double side approach ramp is located on the landward slope. Concrete stairway on waterward slope. (Permit No. 15116-1990) This pipe was installed during the levee work approved under encroachment number 15014. FS Date: 05/19/2015

(2015) View of waterward side--signs of internal erosion along pipe alignment.

UCIP Comments: 05/19/2015 Signs of internal erosion visible on waterward side where pipe daylights. Slope slumping visible on landward side where previous levee damage was present. Need to contact owner and KSN, LMA engineering firm, to coordinate potential issues with pipe. 02/04/2010 Pipe failure--internal erosion visible on waterward and landward side. Recommend LMA superintendent notify owner to stop using crossing to avoid further damage to levee slope. Owner will need to coordinate with DWR Inspector and CVFPB to address pipe failure per Title 23 requirements.

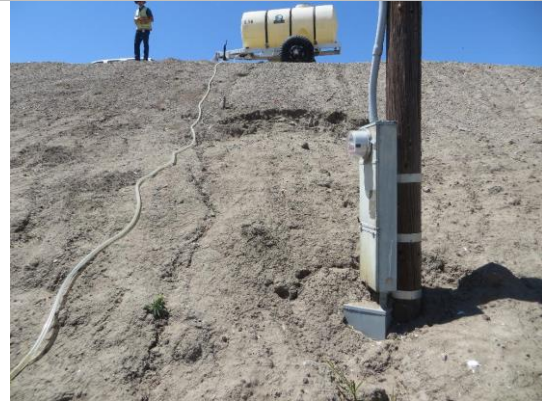
Photo 2 of 3 : UCIP_FA_2015_6013.jpg

(2015) View of landward side--slope slumping at previous damage levee section.

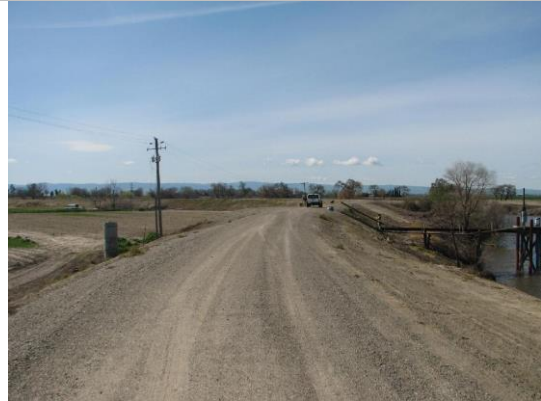
Photo 3 of 3 : UCIP_FA_2015_6186.jpg

Action/Comments					
Inspector Comments: FS_ID:46007 DS_ID:33 EP_NO: 15116 FS_HLM: 4.861 Repair Type: Urgent Crossing Status: Found UCIP Comments: 05/19/2015 Signs of internal erosion visible on waterward side where pipe daylights. Slope slumping visible on landward side where previous levee damage was present. Need to contact owner and KSN, LMA engineering firm, to coordinate potential issues with pipe.02/04/2010 Pipe failure--internal erosion visible on waterward and landward side. Recommend LMA superintendent notify owner to stop using crossing to avoid further damage to levee slope. Owner will need to coordinate with DWR Inspector and CVFPB to address pipe failure per Title 23 requirements. FIELD_STRUCT_DESC: 14 inch diameter pipe through levee. Invert pipe is 4.83 feet below levee crown. Siphon breaker on waterward shoulder. Pump on platform in channel, wooden walkway extends from pump platform to waterward slope, concrete stairway extends from walkway to waterward shoulder. A double side approach ramp is located on the landward slope. Concrete stairway on waterward slope. (Permit No. 15116-1990) This pipe was installed during the levee work approved under encroachment number 15014. FS Date: 05/19/2015

Overview of levee crown at crossing.

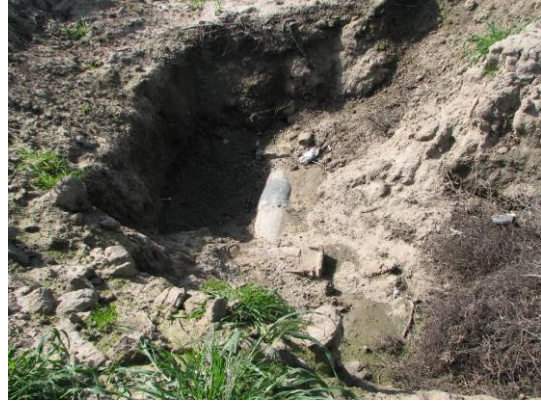
Photo 1 of 3 : UCIP_FA_2015_5513.jpg

LM Start	4.95	Rating **	U	Issue No.	592
LM End	4.95	Issue Type +	En	Location *	LS
Category	Supplemental			GPS Latitude/Longitude	
				Start	End
Item	DWR UCIP Field Study			37.855356 °	37.855356 °
				-121.319849 °	-121.319849 °
DWR ID					
Action/Comments					
Inspector Comments: FS_ID:42878 DS_ID:34 EP_NO: 15117 FS_HLM: 5.008 Repair Type: Urgent Crossing Status: Found UCIP Comments: Section of landward slope exposed--Need to contact owner to address cut on levee and determine status of crossing. Dense vegetation limits the inspector's visibility to identify signs of pipe failure (leaks) along the slope. Recommend removing vegetation along pipe alignment to conduct proper inspection of structure. FIELD_STRUCT_DESC: 10 inch diameter pipeline through levee. Invert of pipe is 4.26 feet below levee crown. Siphon breaker on waterward shoulder. Pump located in excess of 100 feet from the landward toe. Ramp on landward slope. (Permit No. 15117-1989) FS Date: 02/04/2010

Section of levee slope exposed on landward side.

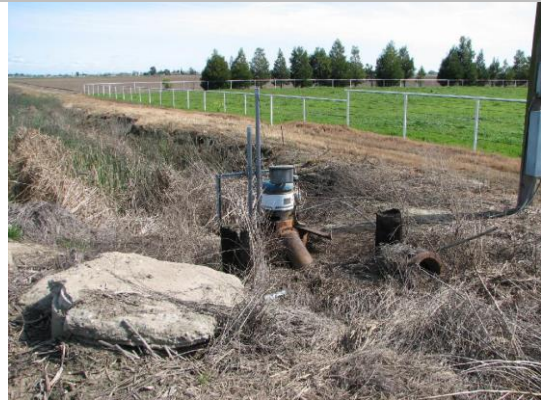
Photo 2 of 3 : UCIP_FA_2015_5514.jpg

Pump station located on landward side toe.

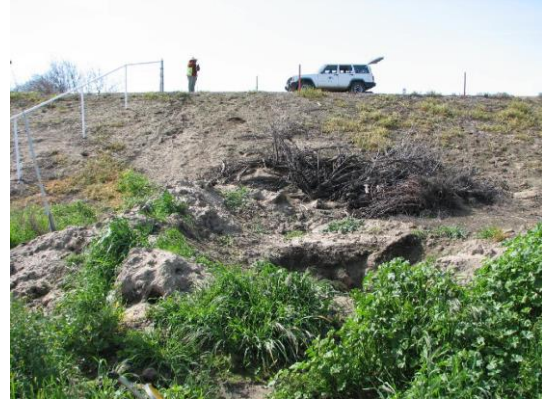
Photo 3 of 3 : UCIP_FA_2015_6440.jpg

View of landward side.

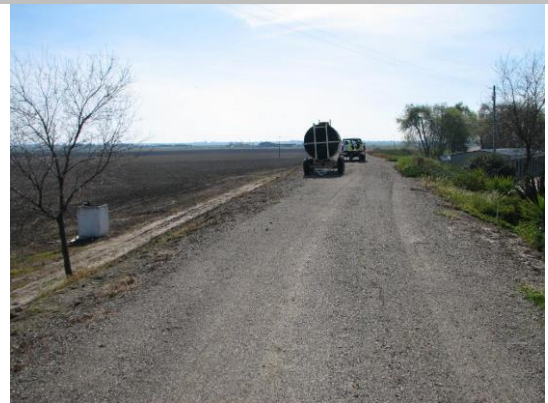
Photo 1 of 3 : UCIP_FA_2015_6327.jpg

Overview of levee crown at crossing.

Inspector Comments: FS_ID:40669
 DS_ID:36
 EP_NO: 15119
 FS_HLM: 5.4811
 Repair Type: Non-Urgent
 Crossing Status: Found
 UCIP Comments: Need to contact owner to determine status.
 FIELD_STRUCT_DESC: 16 inch diameter pipe through levee. Invert of pipe is 5.11 feet below levee crown. Slant pump on riverbank, standpipe located 30 feet from the landward toe. Ramp on waterward slope. (Permit No. 15119-1990). This pipe was installed during the levee work approved under encroachment number 15014.
 FS Date: 02/04/2010

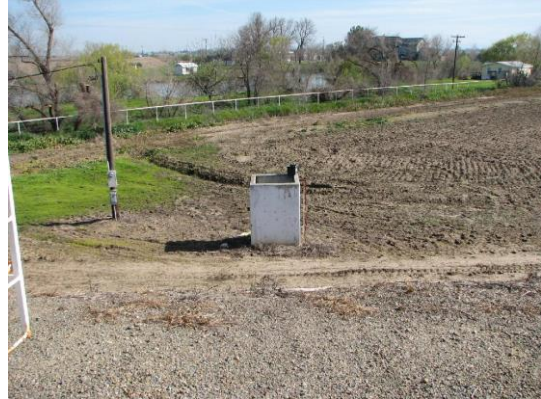
Photo 2 of 3 : UCIP_FA_2015_6441.jpg

Distribution box located on landward side.

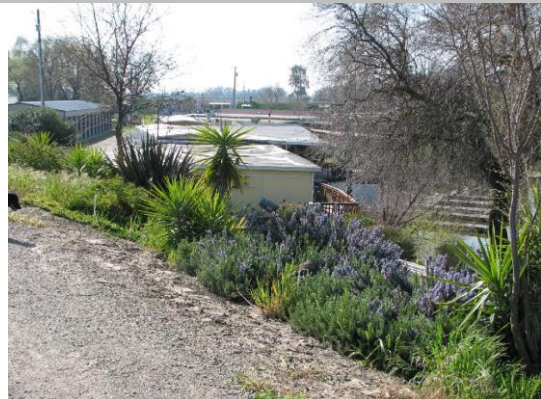
Photo 3 of 3 : UCIP_FA_2015_6442.jpg

View of waterward side.

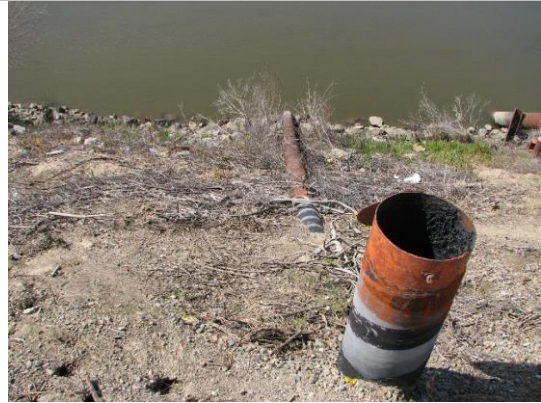
Photo 1 of 3 : UCIP_FA_2015_5899.jpg

Inspector Comments: FS_ID:40672
 DS_ID:38
 EP_NO: 15121
 FS_HLM: 6.2214
 Repair Type: Non-Urgent
 Crossing Status: Found
 UCIP Comments: Pipe section at waterward toe is missing wall. Need to coordinate with owner to determine integrity of pipe section through levee. This crossing is a good candidate for video inspection to determine internal condition of pipe.
 FIELD_STRUCT_DESC: 2 of 2. 10 inch steel stormdrain through the levee 4.0-feet below crown. (Permit No. 15121-1991) This pipe was installed during the levee work approved under encroachment number 15014.
 FS Date: 02/04/2010

View of waterward side.

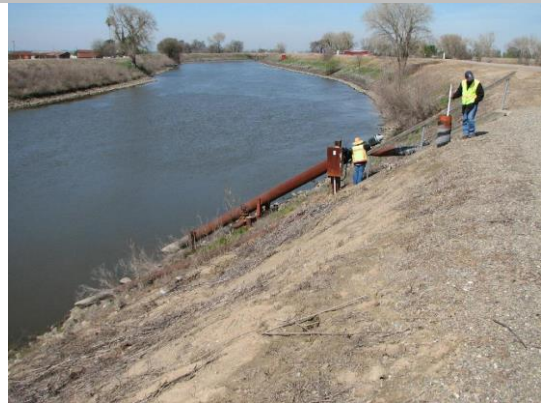
Photo 2 of 3 : UCIP_FA_2015_5900.jpg

View of pipe section on waterward side.

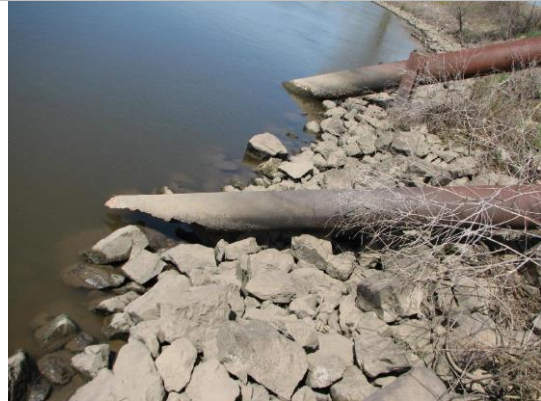
Photo 3 of 3 : UCIP_FA_2015_5901.jpg

Pipe section inside wall has completely corroded--wall missing.

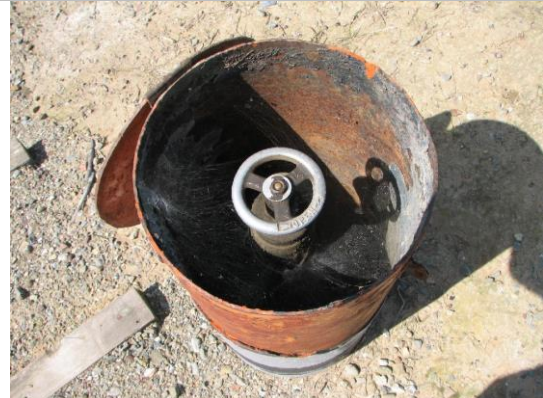
Photo 2 of 3 : UCIP_FA_2015_5504.jpg

Siphon breaker located on waterward side.

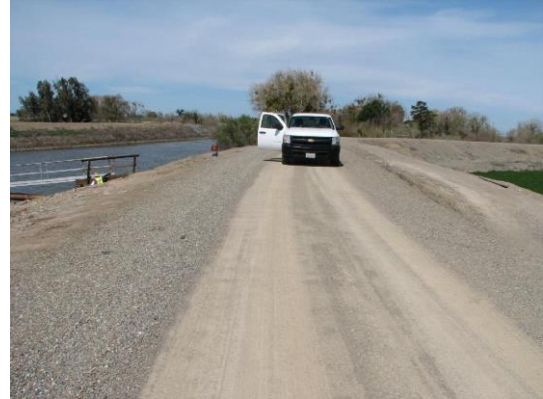
Photo 3 of 3 : UCIP_FA_2015_5902.jpg

View of levee crown at crossing.

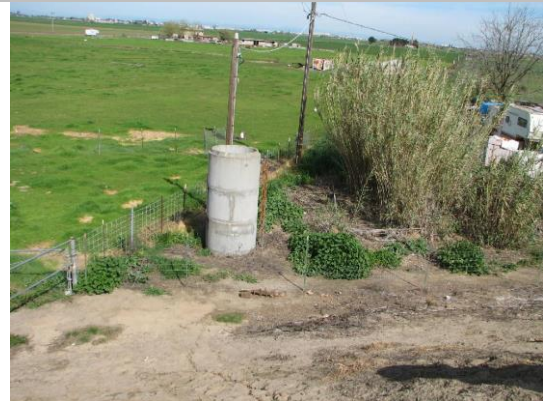
Photo 1 of 3 : UCIP_FA_2015_5505.jpg

Standpipe visible on landward toe.

Inspector Comments: FS_ID:40679
 DS_ID:42
 EP_NO: 15077
 FS_HLM: 7.2603
 Repair Type: Non-Urgent
 Crossing Status: Found
 UCIP Comments: Surface erosion on waterward slope. Abandoned pipe section left on waterward slope. Need to contact owner to obtain additional information about crossing.
 FIELD_STRUCT_DESC: 12 inch diameter irrigation pipeline through levee. Invert of pipe 3.67 feet below levee crown. Siphon breaker on landward shoulder. Pump on platform in channel, walkway from pump platform to waterward shoulder. Standpipe located 15 feet from the landward toe. (Permit No. 15077-1989)
 FS Date: 02/04/2010
